# Manhole Inspection Summary

Manhole # S13U\_\_004MH

Insp Date: **12/9/08 9:00 AM**

**Location** Address: **1063 Parksley Ave**

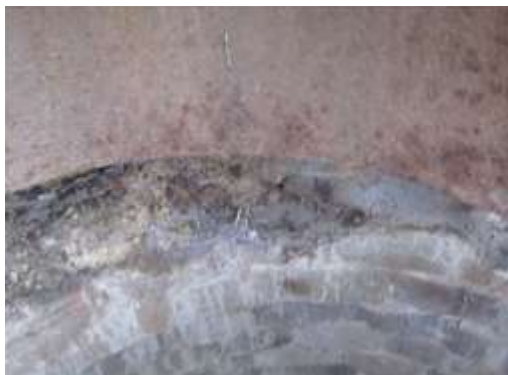
Misc

Condition: ☐ Sound ☐ Cracked ☐ Root Intrusion ☐ Loose Brick ☒ **Deteriorated**

Infiltration: ☐ None ☒ **Joint** ☐ Cracks ☐ Mortar ☐ Roots ☐ Wall

deteriorated corbel and gap bet corbel and frame

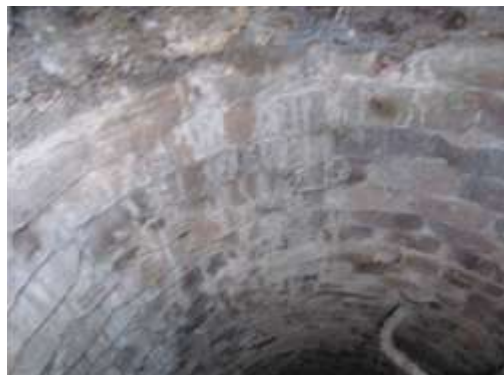
Defect 1

loose bricks,deteriorated corbel, signs of infiltration from frame-corbel joint

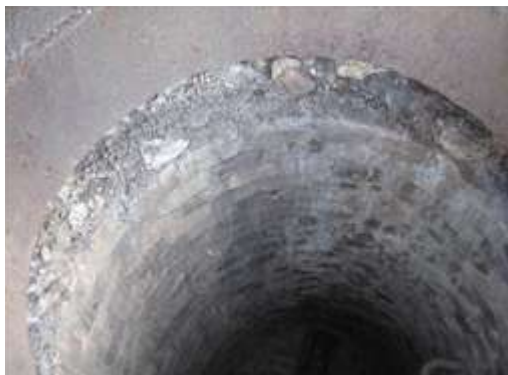
Defect 2

**Frame** Offset: **2** (in.) Condition: ☒ Sound ☐ Cracked ☐ Leaks

offset

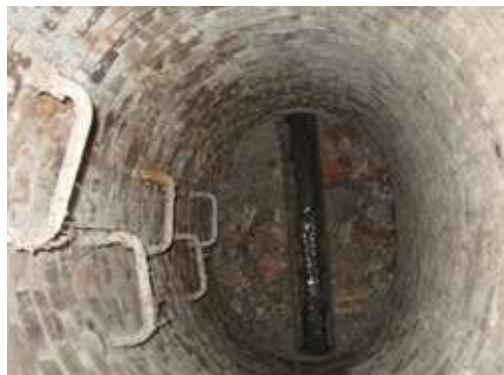
Defect 3

**Steps** Count: **5** Missing: **0** ☒ **Corroded**

corroded steps
